Case Study

BLADEcontrol Delivers Timely Monitoring on Blade Structural Health

Project	Detect spar cap damage and monitor damage growth in California
Customer	EDF power solutions
Solution	BLADEcontrol condition monitoring system with WebVis
Scope	Condition monitoring of wind turbine blades

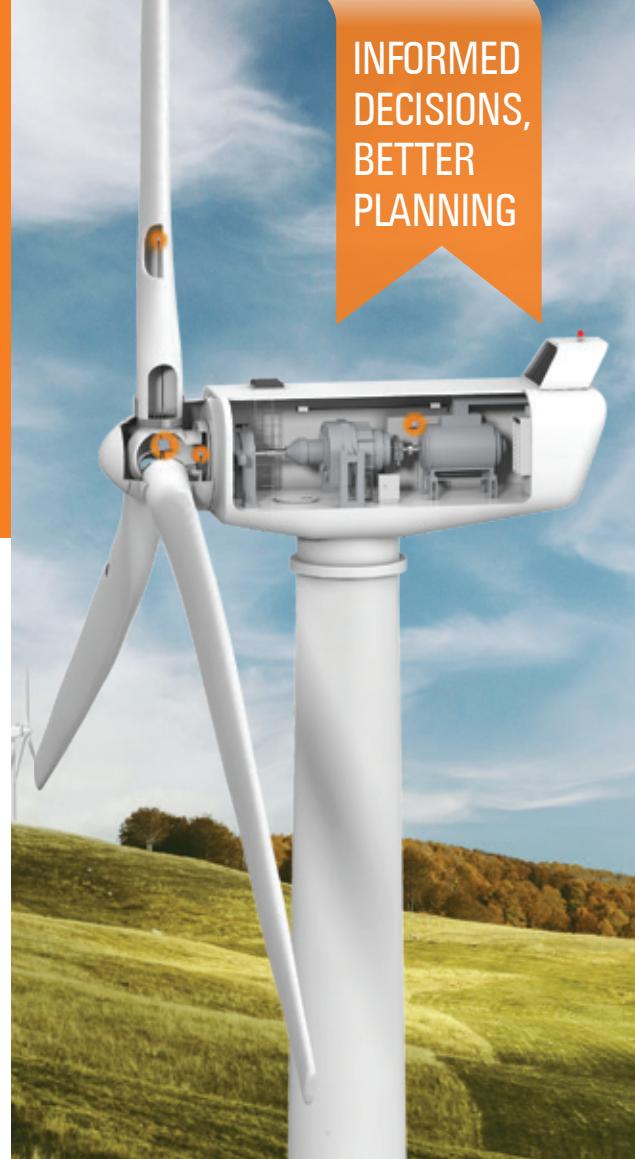
A specific H-Crack (see Figure 1) damage near CoG, previously identified with aerial imagery, was able to be confirmed at the onset of the trial by using BLADEcontrol's advanced condition monitoring system. At the onset, a negligible crack growth was detected and over the ensuing months, the BLADEcontrol system was used to detect any progression of the crack and accurately measure the natural frequencies associated with this damage

Figure 1: Image of H-Crack near CoG.

“ Once the repair was scheduled and completed, the signal energy returned to normal levels and the natural frequencies aligned with the expected peaks associated with an undamaged LM45.3m blade (see Figure 2). **”**
